Lilac LS-18/1 Engine Lubrication Improvements to the One-Piece Crankcase Motor

by David Bernardi

May 1999

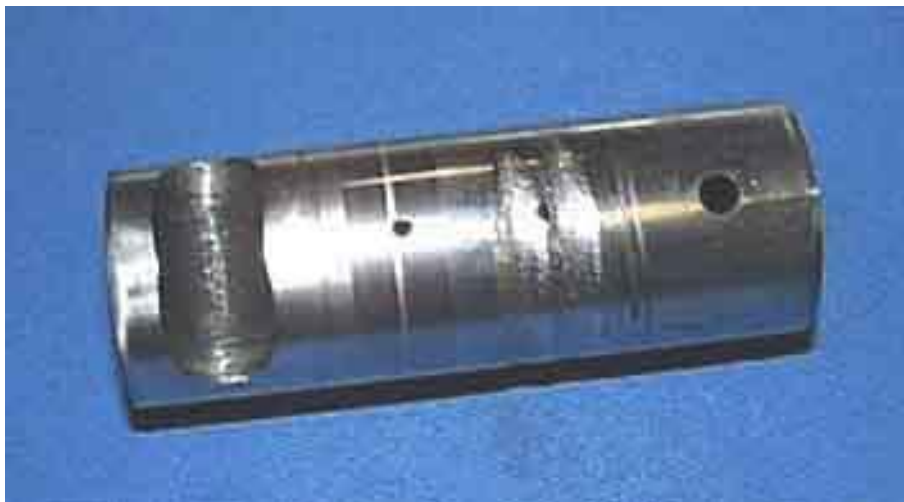
Although I am by no means a Lilac expert, I do know of the sad reputation which Lilac LS-18s have earned regarding their reliability. One of the main flaws appears to be the design of the lubrication system. It appears that the system delivers inadequate oil to the big end bearings, as they seem to fail with remarkable regularity.

Figure 1 shows typical big end damage found on an LS-18/1. Note the twin grooves made by the double row of 5 x 5 rollers on the crank. I have discussed the wisdom of employing this double row arrangement with a number of engine designers. The theory behind this arrangement is that the rollers will not run over the oil hole, thus avoiding stressing the edge of the hole, which could result in fatigue failure. The resulting flakes of metal would then damage the bearing, and like a pot hole in the road, the damage will gradually get worse and worse until the entire bearing fails. The disadvantage is that the available load bearing area is significantly reduced. The consensus is that, although the practice is sound in high speed, highly-stressed engines, an engine with a compression ratio of 7.8:1 and a maximum speed of around 7,000 rpm is not going to stress things up that much. High performance four strokes with built-up cranks and much higher specific outputs (e.g. the Suzuki GS series, to cite one example I am familiar with) run full-length rollers without problems.

So, recommendation number 1: If rebuilding the crank, or even if you have one that hasn't failed yet (buy a lottery ticket!) replace the 5 x 5 rollers with 5 x 10s. The bearing area will be significantly increased, and so will the life of your big end.

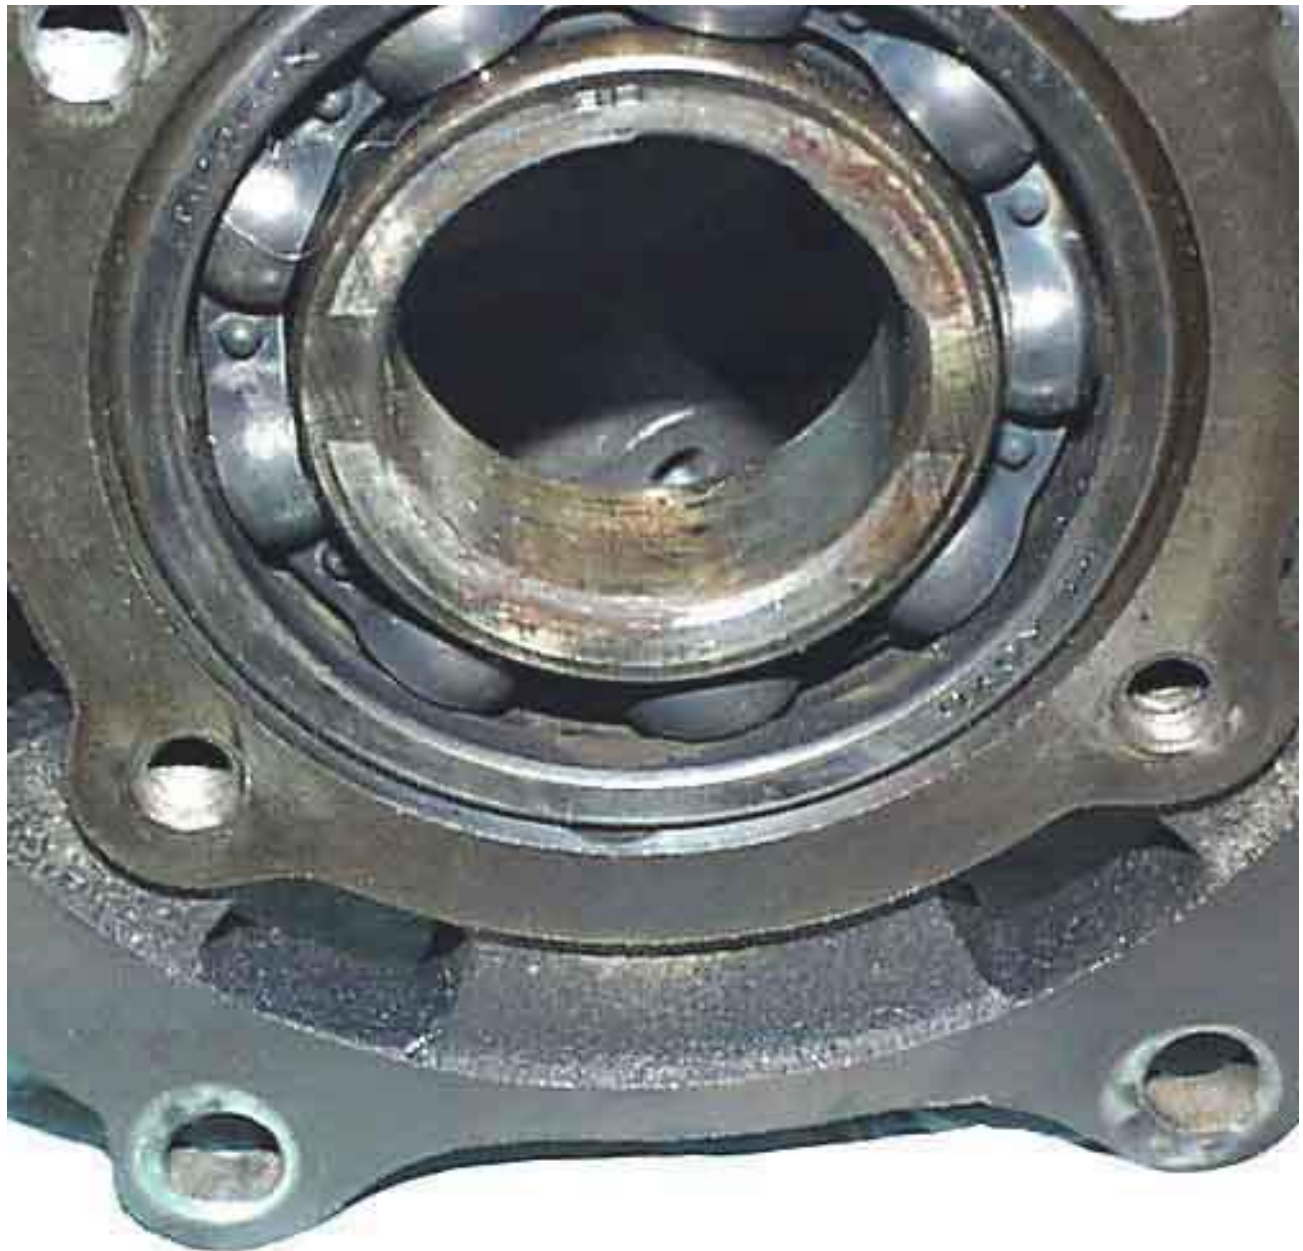
Figure 2 shows the standard passage between the bearing and its housing (note, a magnifying glass, or better still an electron beam microscope, may be required to see the passage). The passage is so tiny that at best the oil flow would be miniscule. In the early sixties, before multigrade oils with detergent properties were available, a cold start would have seen no oil coming through here, and the slightest buildup of sludge would have blocked it off for good.

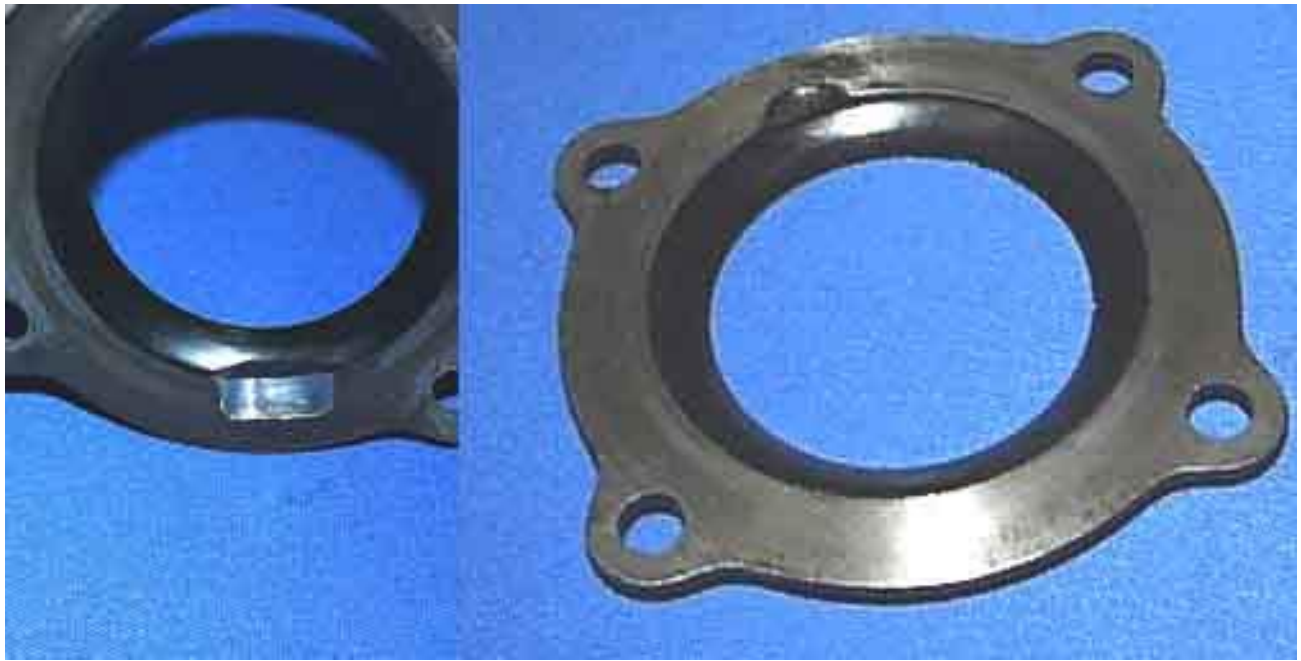
Figure 4

The next step is to turn our attention to the bearing retainer/face seal. This has a slight depression for the oil to pass through. My initial thoughts were to enlarge this passage and leave it at that. **Figure 4** shows before and after pictures. I was concerned, however, that the seal material had taken on the flexibility and suppleness of glass, a result of old material technology combined with age (40 years is a long time for an oil seal). I could not trust the old seal to do its job, so I looked into another solution.

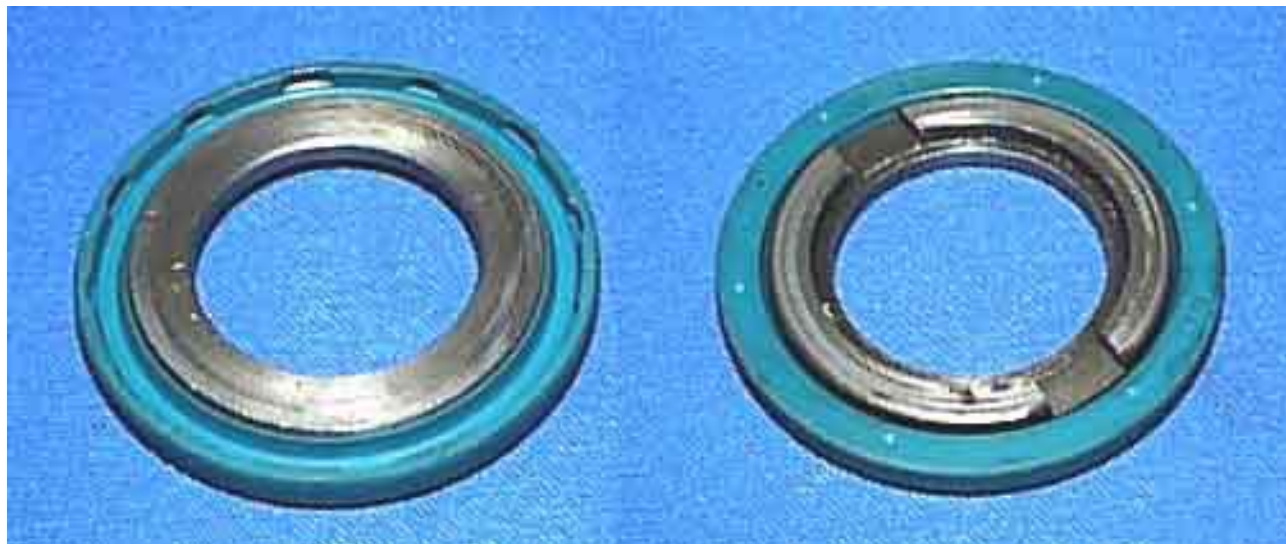
The main problem I felt was the reversed seal, which would probably work satisfactorily, but was just 'not the done thing'. If all I had was a small lathe in my garage, or had to pay to get these modifications done, I would probably use this design as the seal housing could be very easily turned up and the existing timing gear spacer used. Remember that the other side of the chamber is sealed by the lip seal of a sealed bearing, which is very fine and has no rated pressure-sealing capacity. Also, the original face seal was designed 'wrong', in that oil pressure also lifted the seal, rather than assisting it.

I found a single lip, non-spring-loaded seal only 4mm thick, made by INA. This was ideal. My first design employed a 38 x 48 x 4 seal, sealing on the spacer ring between the bearing and the timing gear. The ring is 38mm diameter, and so would only require to be polished on the outer surface for the seal to run on. This design has two problems: Firstly, the seal must be installed backwards to avoid the lip running over the cutouts in the spacer. This results in oil pressure lifting the lip, rather than assisting it to seal. Secondly, the bearing inner is about 38mm diameter, and so the oil has very little space to squeeze through between the seal and the ring. I used a bearing which was sealed both sides and removed the seal from one side. The inner ring of the bearing is reduced in diameter where the seal ran, and so, fortuitously, extra clearance was available for the oil to pass.

Figure 5 shows the seal assembled on to the spacer ring.

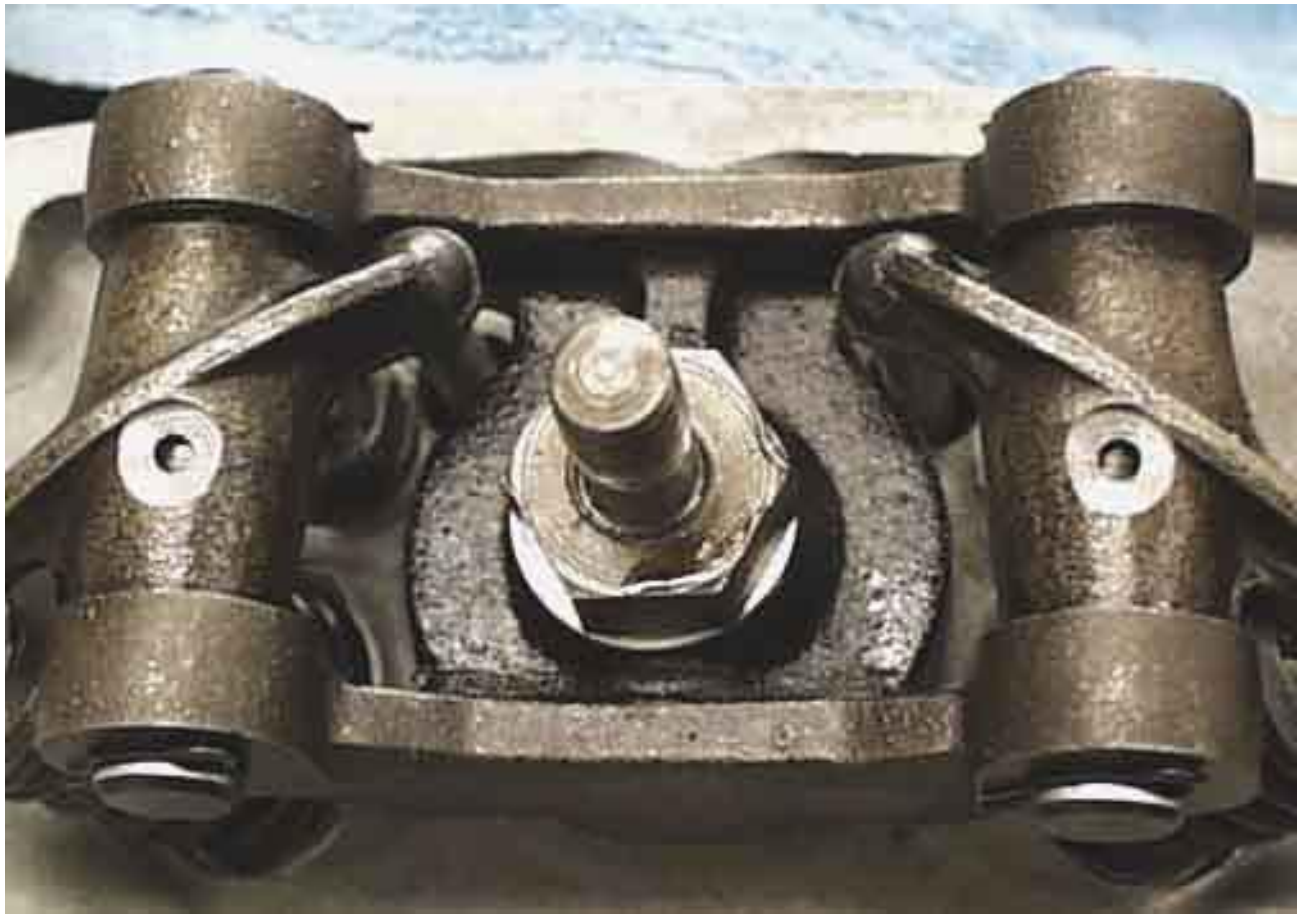
Another area of concern to me is the lubrication of the valve and rocker gear. Most pushrod engines flow oil into the cam follower, up through a hollow pushrod, then into the rocker and, via drillings in the rocker, to the rocker shaft. The LS-18 flows oil up the OUTSIDE of the pushrod, in the pushrod tube, and then it is supposed to splash around in the rocker box, in the slim hope that some may miraculously find its way into the tiny drillings in the rocker to allow some lubrication for the rocker shafts. Although not too badly damaged, all my Lilac engines show some signs of picking up or galling of the rocker shafts. A quick and easy modification I made was to put large countersinks in the rocker oil holes to try and funnel a little more oil into the shaft. In my opinion it can only help.

Figure 8 shows the modified rockers.
